1.1 Introduction

1.2 My role in the department

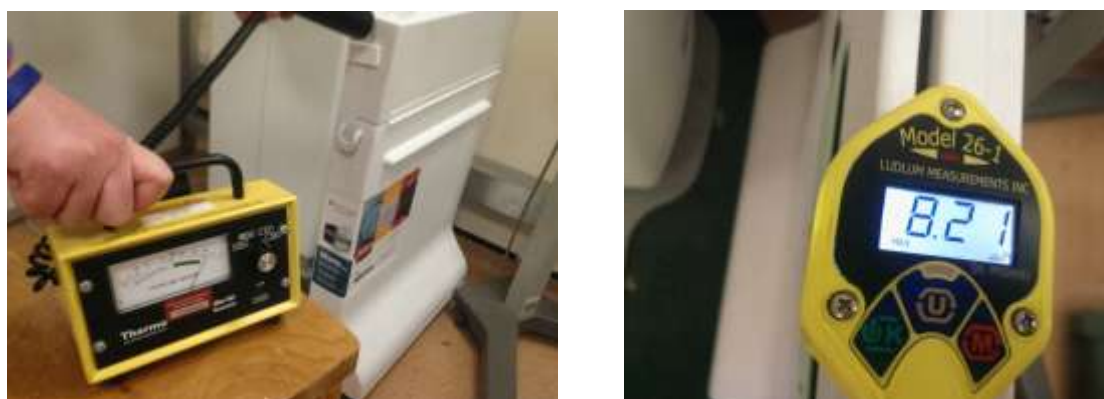
We purchased a shielded rolling case for the ^{57}Co source to ensure it could be shielded whilst being transported. It is a flood source and so has a large surface area (620 x 420mm) so it is important to ensure that all parts of the source are adequately shielded before transporting. We carried out an assessment of the package to determine the dose rate at the surface. This was done initially by using a contamination monitor to look for 'hot spots' where a high dose rate may be measured [C3]. We did this by holding the contamination monitor at arms-length to maximise the distance from the source and systematically sweeping around the package checking all surfaces. This method is typically used to find regions of interest that warrant further investigation using a dose rate meter. Most of the package appeared to be adequately shielded; however there was a hot spot towards the top corner of the package:

Figure 3.1b - contamination and dose rate monitoring of ^{57}Co source package

Further investigation was then performed on the hot spot to determine the actual dose rate at the surface. This was done using a hand held dose rate meter and as can be seen in Figure 3.1b, the dose rate measured at the surface was $\sim 8\mu\text{Sv h}^{-1}$. This was in excess of the maximum limit for an excepted package. We could have still transported the source as it was as a Category 1 or 2 package, but this would have required additional signage and driver training. The other alternative was to add some additional shielding to the container to bring the dose rate down sufficiently. We used some Pb rubber to do this and carefully lined the whole of the inner compartment of the container. The source was removed from the container whilst this work was carried out and placed into a safe storage area so we were not at any risk when carrying out this work. The flood source has built-in handles to allow us to move it around easily and these areas are free from Cobalt, nevertheless it is important to minimise the time holding the source and to hold it away from our bodies to ensure the risk from exposure is kept as low as possible.

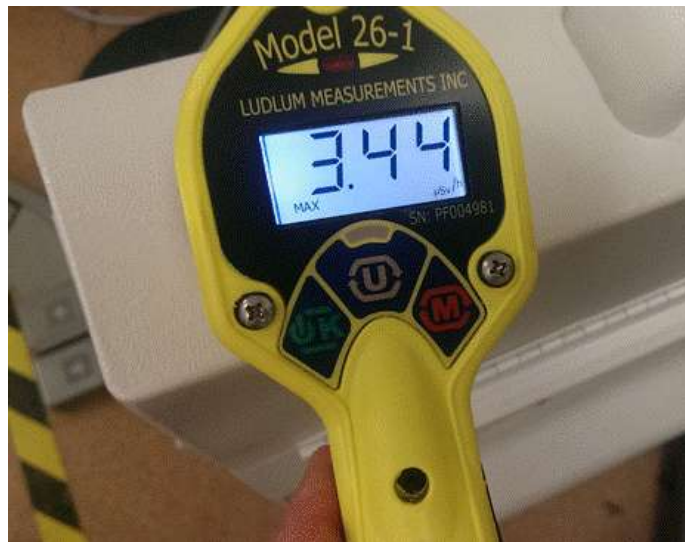
Once completed, the source was put back into the container and the measurements were repeated. All surfaces of the package were re-tested using the hand held dose rate meter. The additional shielding proved to be sufficient to bring the dose rate down below the $5\mu\text{Sv h}^{-1}$ limit (Figure 3.1c) [C1].

Figure 3.1c - follow up dose rate checks on ^{57}Co package

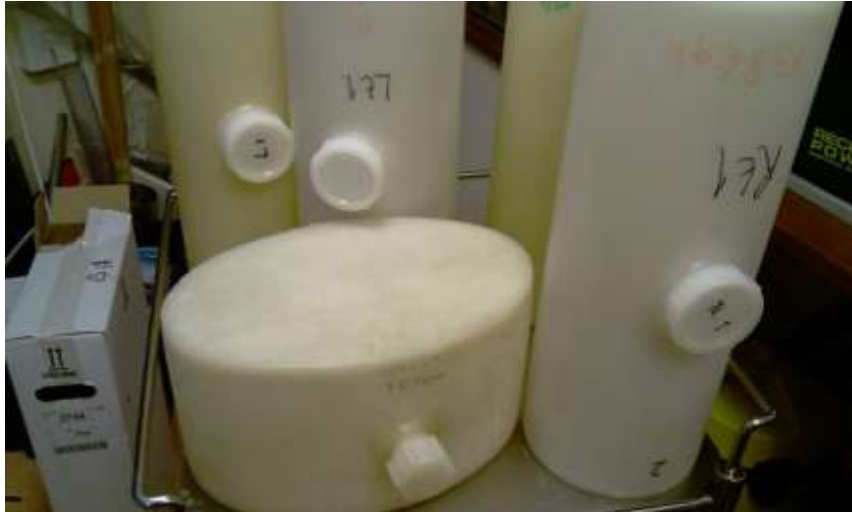
To simulate the body in the image, I used several containers filled with water to create the approximate size of an orthopaedic patient. The containers come in a variety of different shapes and sizes so it was possible to combine some that could simulate the size of a small adult. These were all then filled with water ensuring there were no air pockets left in. As the human body is ~70% water, this was a good approximation and will offer an equivalent attenuation of the beam as a patient would.

Figure 7.1 - containers used for body phantom

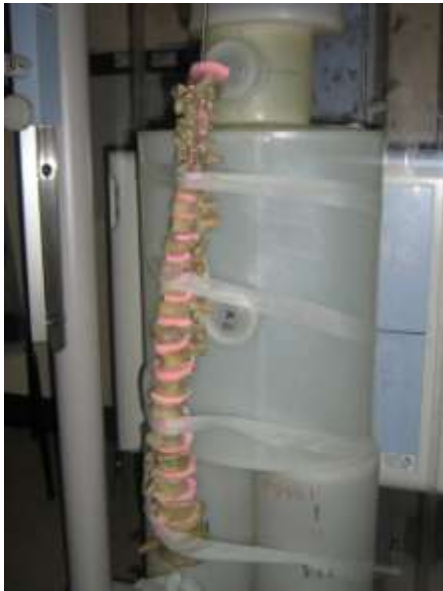
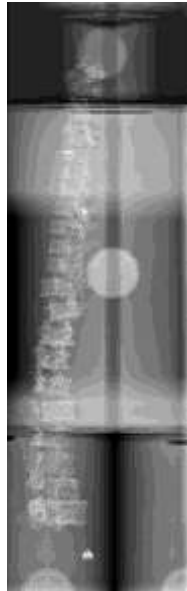
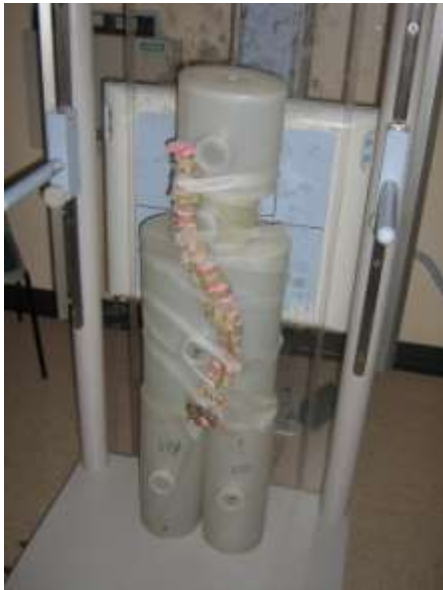
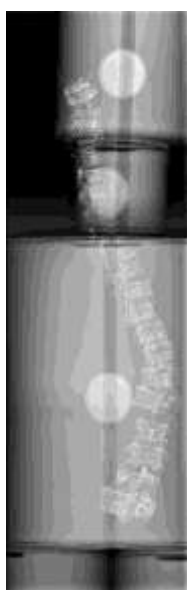
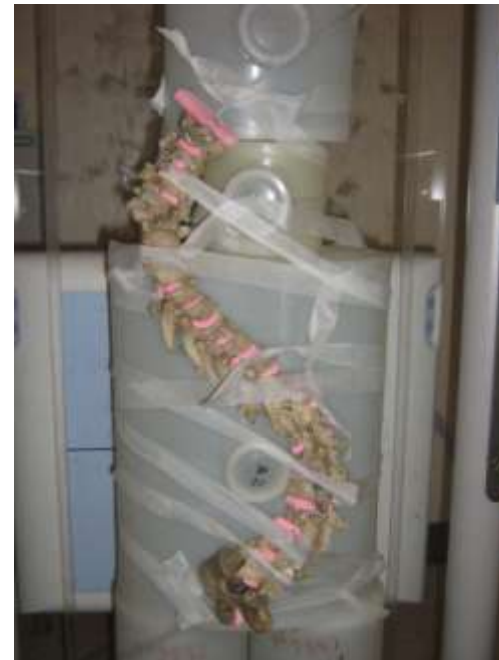
Figure 7.3 - photos of the experimental setup and resulting images from clinical exposures. Each exposure simulated a higher degree of scoliosis to fully test the capabilities of the system

I worked closely with the help of the lead radiographer in orthopaedics who initially reported the problem. Together we positioned the body phantom and spine test tool in a typical clinical orientation and I assisted the Radiographer in making the exposures. The severity of the scoliosis was altered throughout the testing so we had a good range of images to test the system with. Several exposures were made at each setting so we had a good selection of images to analyse. The exposures were made using the standard protocols they would normally use and they also did the image analysis as per their protocol.

Some sample images along with photos of the experimental setup are shown on the following page in Figure 7.3.

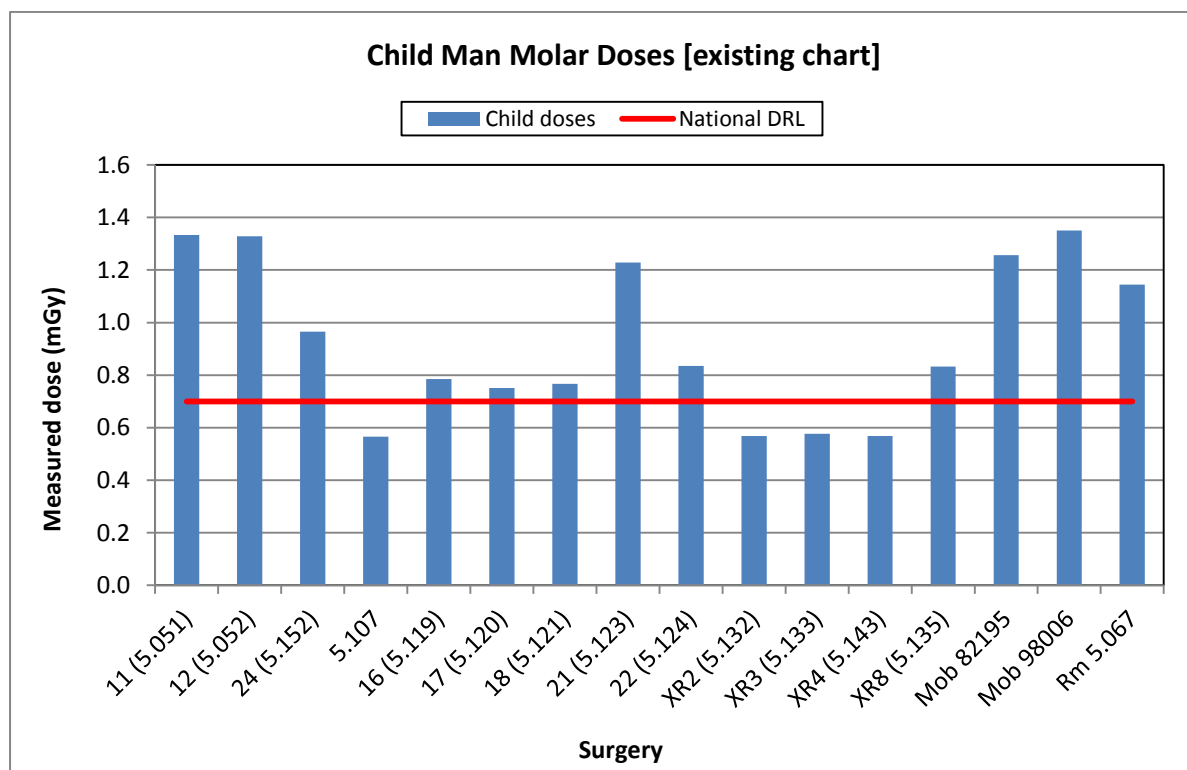
In the technical manual for the VistaScan systems is a recommended exposure chart for use with their dental CR systems. This information has been carefully considered when carrying out this work to ensure that patient doses can be As Low As Reasonably Practicable (ALRAP) whilst ensuring dose levels remain sufficient for the CR system to produce radiographs of diagnostic quality. The chart below shows the locations of the surgeries which are exceeding the Child National DRL in their current operation:

Our survey results showed that 75% of all the systems we tested gave dose levels which currently exceeded the Child National DRL using the provided exposure charts. All the systems which exceeded the DRL are Planmeca Prostyle Intra systems. These are currently operating at the default tube current of 8mA. Our tests show that simply by reducing the tube current to 7mA (which is the same as the Instrumentarium systems), and coupled with the correct exposure chart which is provided below, doses would be reduced sufficiently to ensure most would fall below the National DRL.

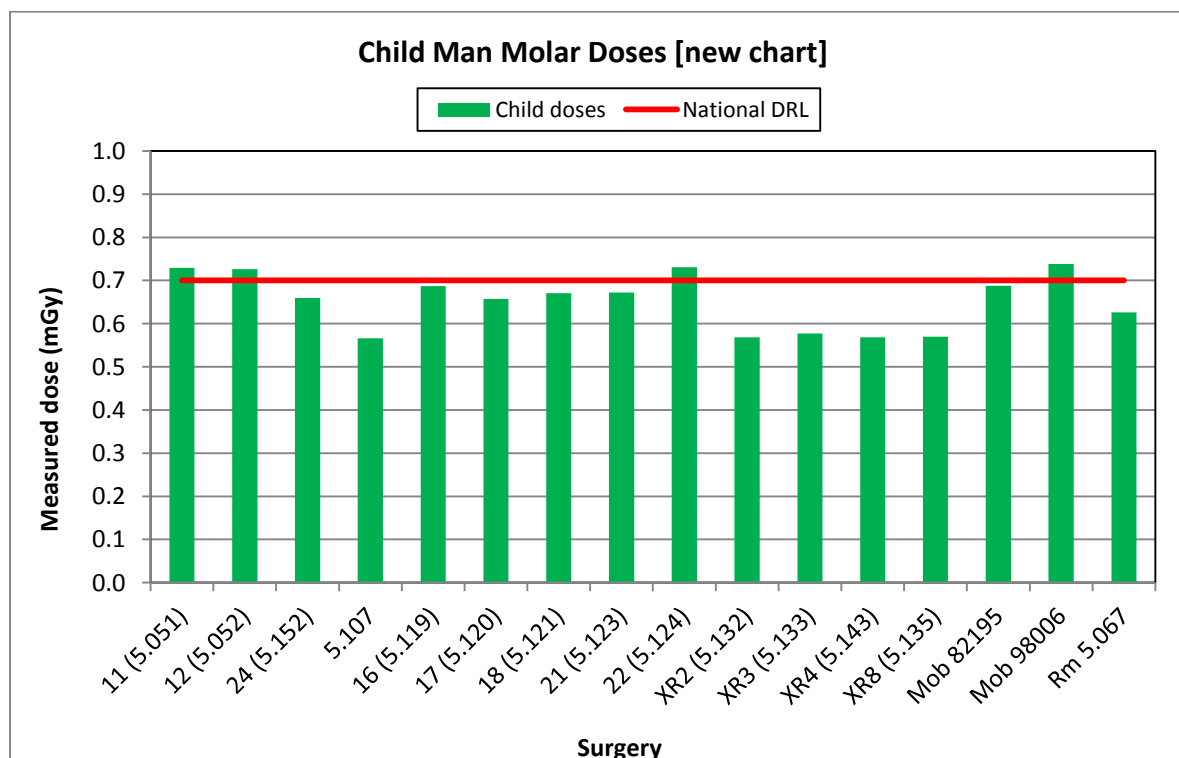
The proposed changes to the exposure chart will reduce the doses to a level where most fall under the National DRL. Furthermore doses will be more consistent across all the surgeries as a standard set of exposure factors will be used by all departments.
