1.1 Introduction

1.2 My role in the department

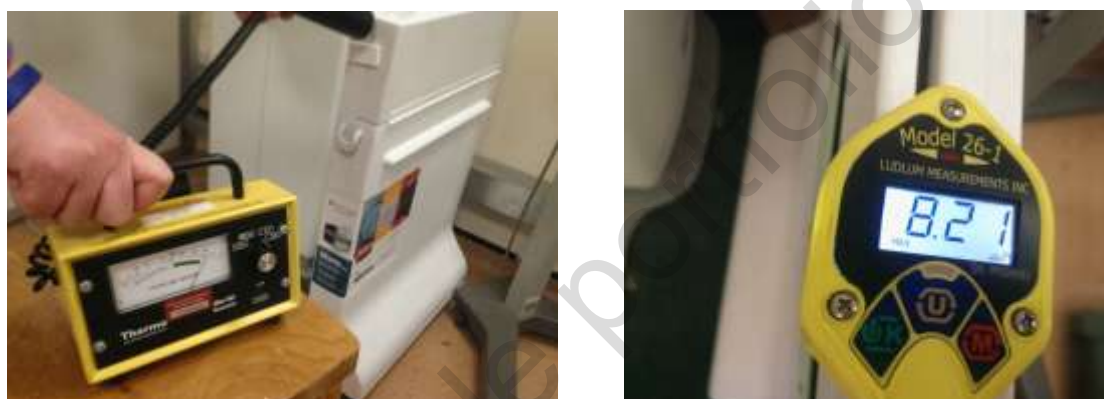
We purchased a shielded rolling case for the ^{57}Co source to ensure it could be shielded whilst being transported. It is a flood source and so has a large surface area (620 x 420mm) so it is important to ensure that all parts of the source are adequately shielded before transporting. We carried out an assessment of the package to determine the dose rate at the surface. This was done initially by using a contamination monitor to look for 'hot spots' where a high dose rate may be measured [C3]. We did this by holding the contamination monitor at arms-length to maximise the distance from the source and systematically sweeping around the package checking all surfaces. This method is typically used to find regions of interest that warrant further investigation using a dose rate meter. Most of the package appeared to be adequately shielded; however there was a hot spot towards the top corner of the package:

Figure 3.1b - contamination and dose rate monitoring of ^{57}Co source package

Further investigation was then performed on the hot spot to determine the actual dose rate at the surface. This was done using a hand held dose rate meter and as can be seen in Figure 3.1b, the dose rate measured at the surface was $\sim 8\mu\text{Sv h}^{-1}$. This was in excess of the maximum limit for an excepted package. We could have still transported the source as it was as a Category 1 or 2 package, but this would have required additional signage and driver training. The other alternative was to add some additional shielding to the container to bring the dose rate down sufficiently. We used some Pb rubber to do this and carefully lined the whole of the inner compartment of the container. The source was removed from the container whilst this work was carried out and placed into a safe storage area so we were not at any risk when carrying out this work. The flood source has built-in handles to allow us to move it around easily and these areas are free from Cobalt, nevertheless it is important to minimise the time holding the source and to hold it away from our bodies to ensure the risk from exposure is kept as low as possible.

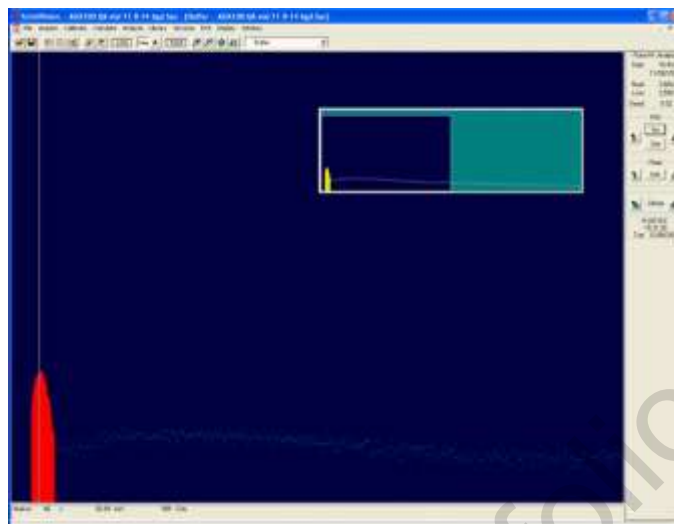
The results are then analysed and the graph is checked to see the count rate across the energy range. Ideally we would expect to see a flat line across the chart as show in Figure 3.2a, as this would indicate nothing but background radiation has been detected.

Figure 3.2a - sample results of wipe tests showing nothing above background

If the activity of the wipe is measured to be $<200\text{Bq}$, as specified in Medical & Dental Guidance Note (8.37), then the source is considered to be leak free. Anything above 200Bq , or any peaks on the graph above background would immediately point to there being a contaminated sample on one of the wipes and therefore would have failed the test.

All the wipe tests I have carried out have shown similar results to those shown in Figure 3.2a and have indicated that there was no contamination present. If however I did detect any contamination on the wipe, I would immediately remove the source in question from service. I would show the results to a more senior member of the department, for example a Clinical Scientist and assist in investigating the problem further. The source would be placed in a safe environment whilst I investigate the surrounding areas and check for contamination. One possible reason for the source to fail this test is that the container has become damaged. This could be physical damage which may have occurred from mishandling the source, or the container may have broken down over time due to damage caused by the source itself. Any physical damage of the container can be visually checked and suspect areas can be checked further for contamination. I would assist in the process of decontamination of surrounding areas. If the source cannot be adequately decontaminated or moved to a suitable container, it must be disposed of.

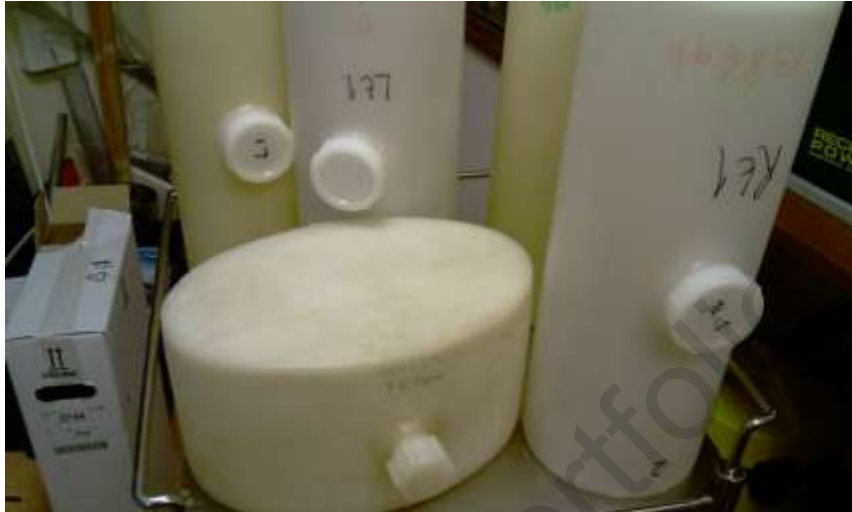
To simulate the body in the image, I used several containers filled with water to create the approximate size of an orthopaedic patient. The containers come in a variety of different shapes and sizes so it was possible to combine some that could simulate the size of a small adult. These were all then filled with water ensuring there were no air pockets left in. As the human body is ~70% water, this was a good approximation and will offer an equivalent attenuation of the beam as a patient would.

Figure 7.1 - containers used for body phantom

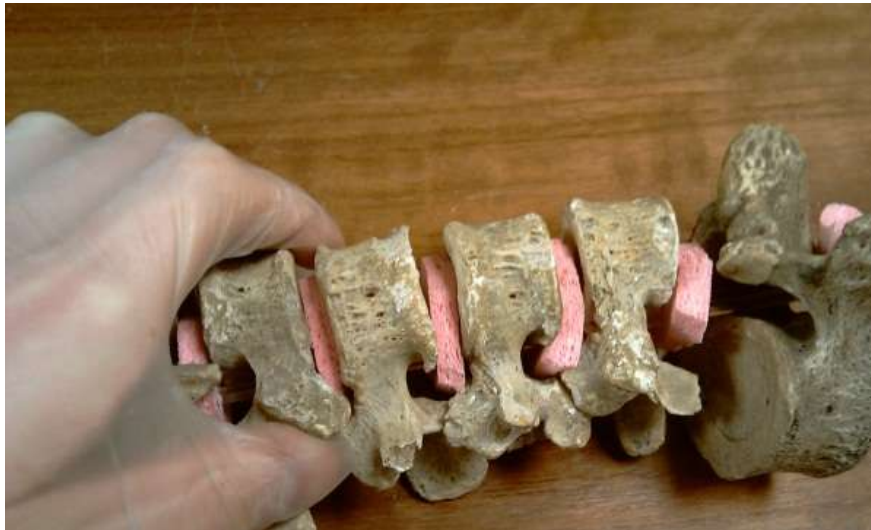
Each of the spinal vertebrae was attached to a flexible plastic rod. I needed to put a spacer in between each vertebra to simulate the intervertebral discs so they were not touching each other when the rod was bent. I decided to use a thin piece of kitchen sponge between each of the vertebrae to simulate this. At all times whilst developing and using the test object, I wore protective clothing whilst handling the body parts. This included gloves and also a facemask to protect myself when creating the test object in our workshop. The test object was stored away at all times when it was not in use to prevent any cross contamination. Furthermore I gave consideration to members of the public, particularly young children who may be sensitive/upset to seeing human body parts like this so it was always covered when transporting it around the hospital. The finished test object is shown in Figure 7.2.

Figure 7.2 - creating the spine phantom

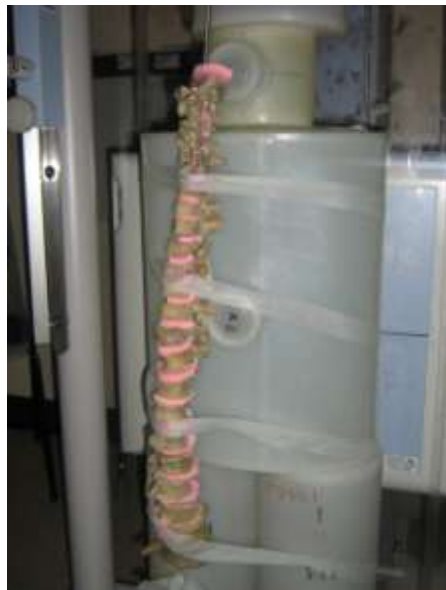
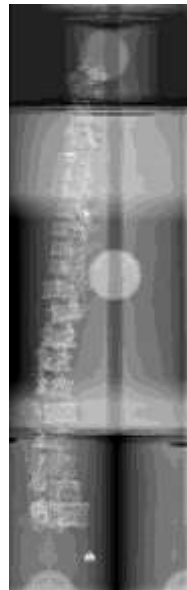
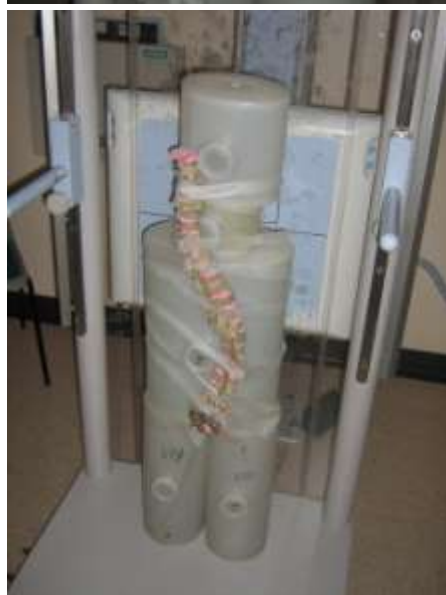
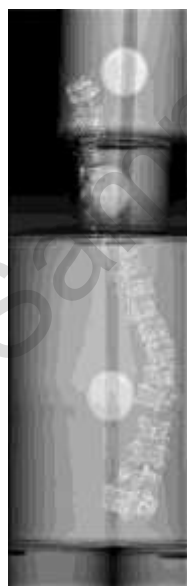
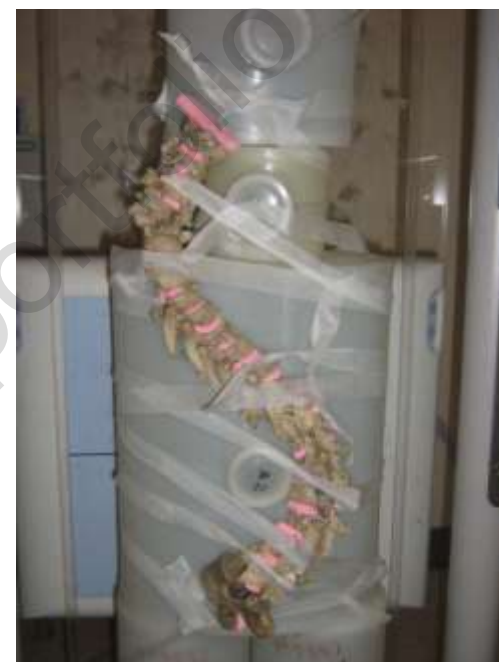
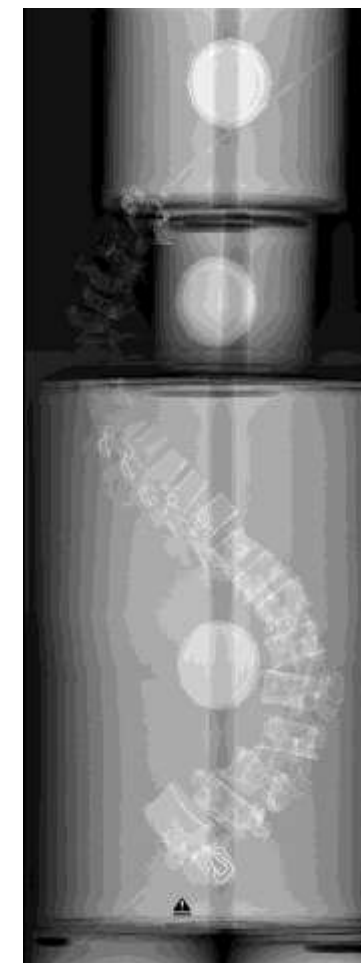
Figure 7.3 - photos of the experimental setup and resulting images from clinical exposures. Each exposure simulated a higher degree of scoliosis to fully test the capabilities of the system

Some sample images along with photos of the experimental setup are shown on the following page in Figure 7.3.
